Wood-RISE Alliance Webinar

Fire design of exposed mass timber in apartments

Fire Safe Implementation of Visible Mass Timber in Tall Buildings

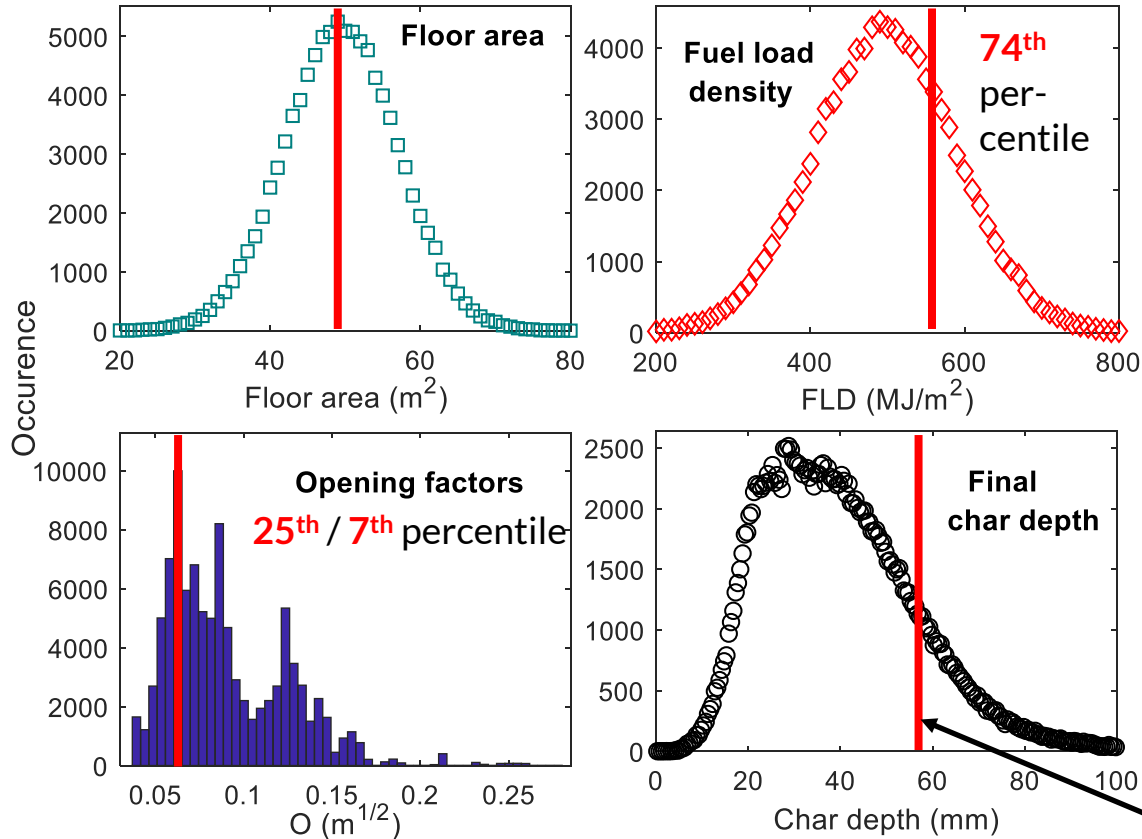
Design values – Severe but representative

- Floor area 49m²
- Opening factor 0.062m^{1/2}
- Fuel load density 560 MJ/m²
- 85th percentile damage

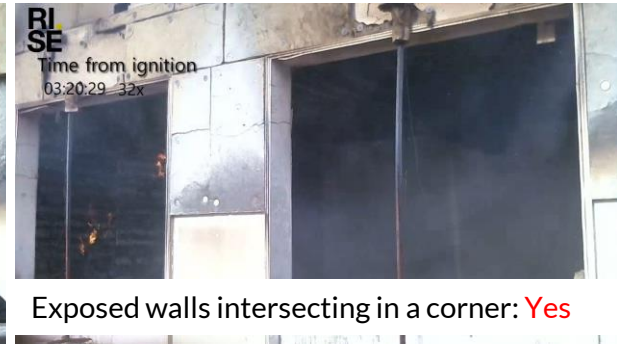
Exposed walls intersecting in a corner: **Yes**

Test 3 - Exposed timber: 96.2 m²

- Fire in the compartment with the ceiling exposed and walls protected with 2 layers type-X gypsum boards, decayed at least up to 4 hours after ignition.
- Fires in compartments with significant areas of additional exposed wall surfaces, decayed at least up to 4 hours after ignition, with one exception where exposed wall surfaces intersected in corners and increased damage in the bottom of corners was observed.

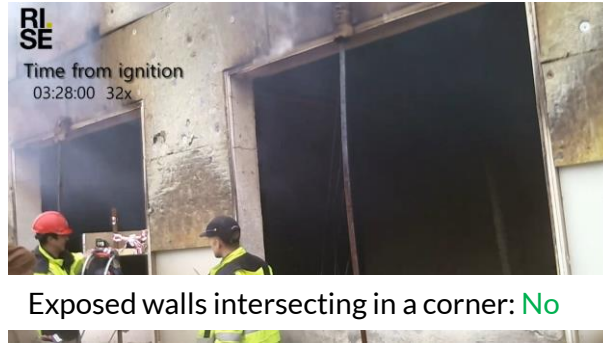
Exposed walls intersecting in a corner: **No**

Test 5 - Exposed timber: 97.2 m²
